Building Inspection Report

1000 Pike ST NE Auburn WA 98000

Inspection Date:
6/11/2011

Report Number:
111092
ICN
9282BA030

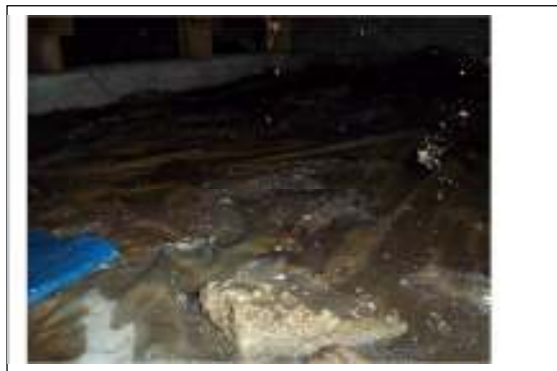
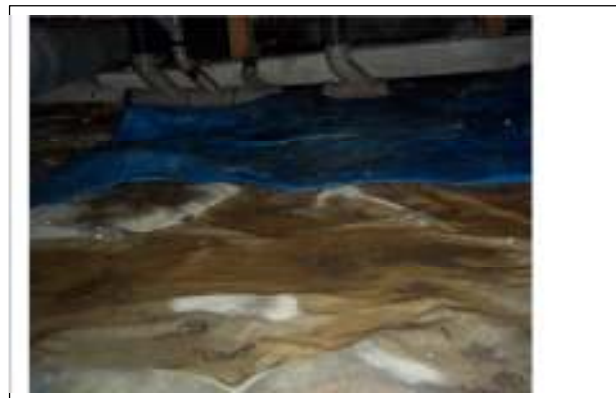
Crawl Space

- **Repair:** Standing water was observed in the crawl space. Wet crawl spaces risk building damage from rot and insects and can cause interior mold or mildew. Roof and lot drainage repairs or improvements should be addressed as a first step to controlling water in the crawl space (see “Exterior”). This condition should then be monitored to determine if additional, potentially costly measures are necessary. See Plumbing Section for additional information.

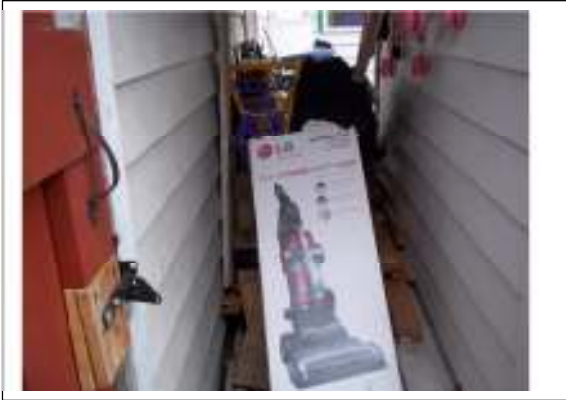
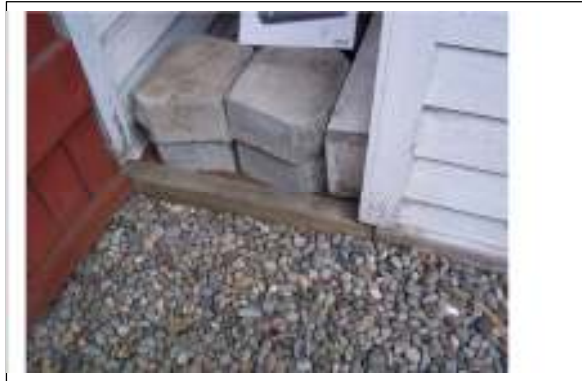
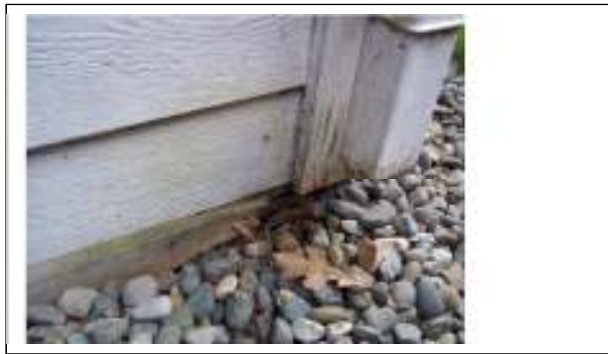
Wood Boring Insects

- **Repair:** Evidence of wood destroying insect activity was observed. If the property has not already been treated, a licensed pest control specialist should be engaged. Wood destroying insect can do a substantial amount of damage to the wood structural components of a home.
- **Repair:** Wood/soil contact should be eliminated along the north side of the storage shed form boards. This condition risks rot and wood boring insect activity.

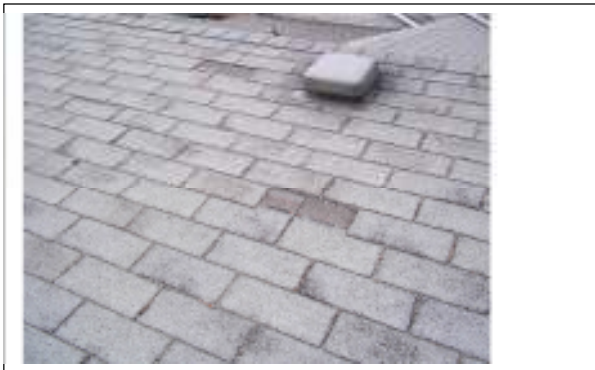
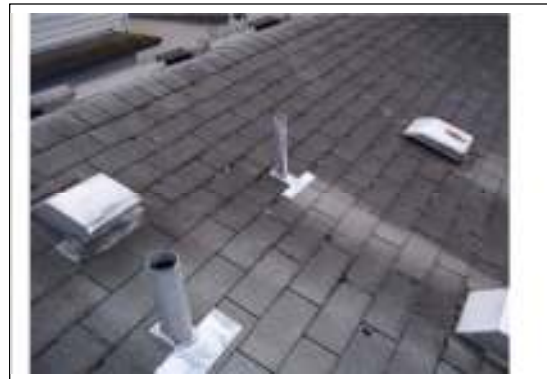
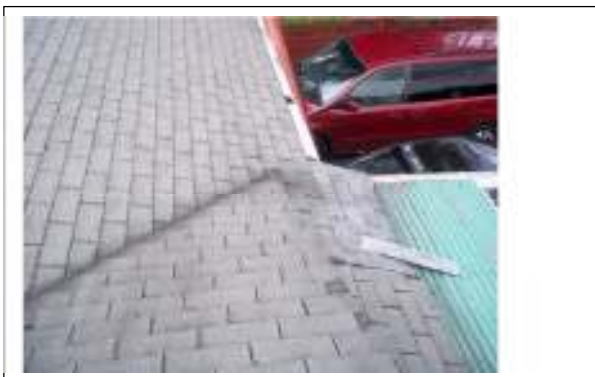
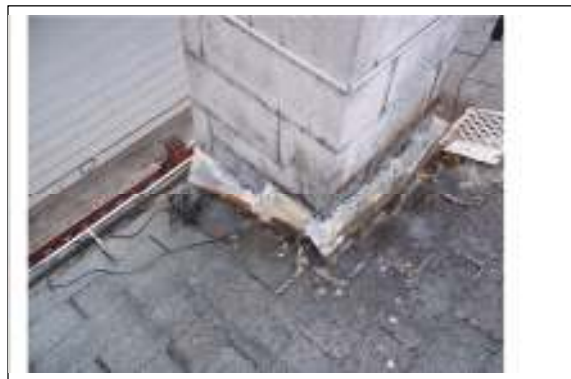
Sloped Roofing

- **Major Concern, Repair:** The roofing is at end of life and should be replaced. Vulnerable areas noted.

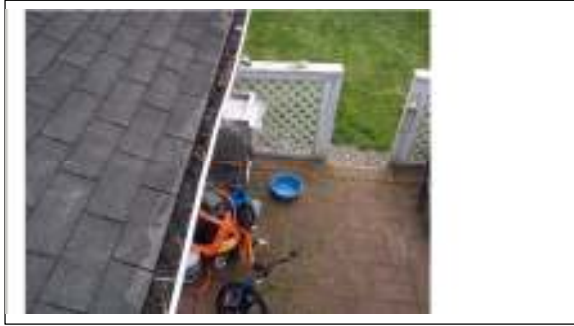
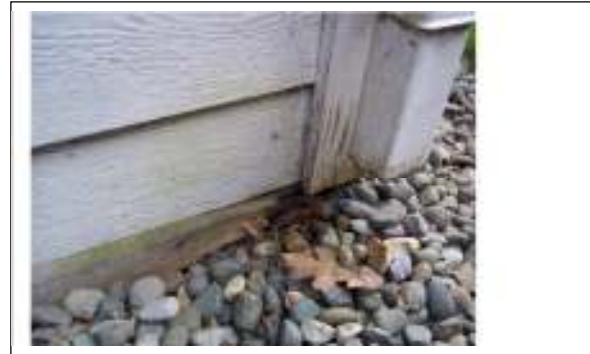
Gutters & Downspouts

- **Repair:** The gutters require cleaning to avoid spilling roof runoff around the building – a potential source of water entry or water damage. Minor repairs needed to assist water away.

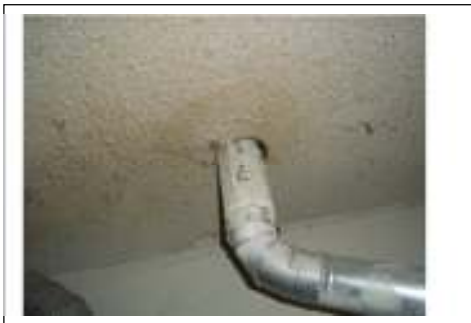
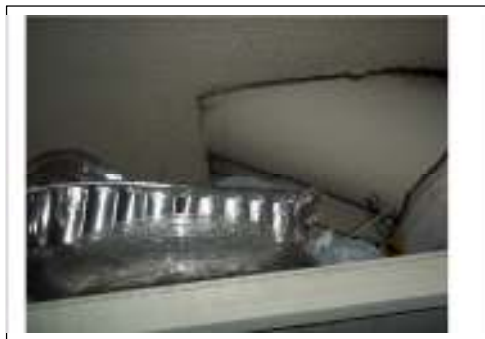
Garage / Shed Storage

- **Repair, Safety Issue:** Proper fire separation between the garage and house proper is recommended at the HVAC duct through ceiling. Additionally several holes are observed throughout garage ceiling that are in need of repairs.

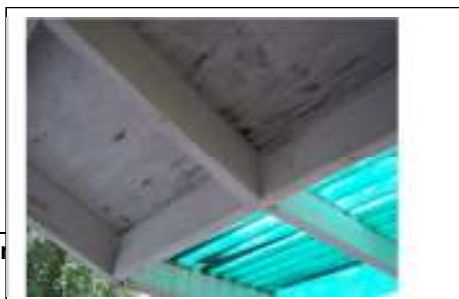
Porch / Deck Cover

- **Repair:** The deck/porch cover at the front patio is causing deterioration (rot) to the eave overhang. It should be repaired or replaced as necessary when re-roofing. Corrections to porch cover drainage as needed to avoid future damage.

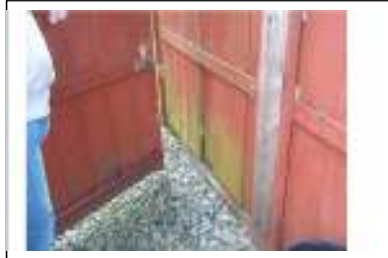
Fencing

- **Repair:** The gate and latch mechanism needs adjustment to function properly. South side.

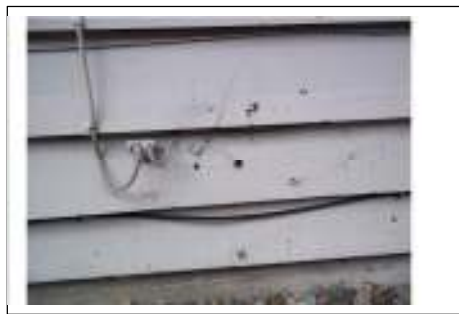
Exterior Walls

- **Repair:** several holes are noted in exterior walls from utilities etc. recommend a full examination of the exterior and repair as needed.

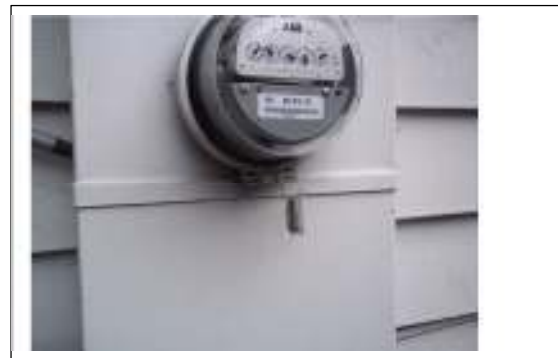
Main Panel

- **Major Concern, Repair:** The main distribution panel should be moved to an appropriate location. Additionally the utility company lock out tag has been tampered with at the meter.

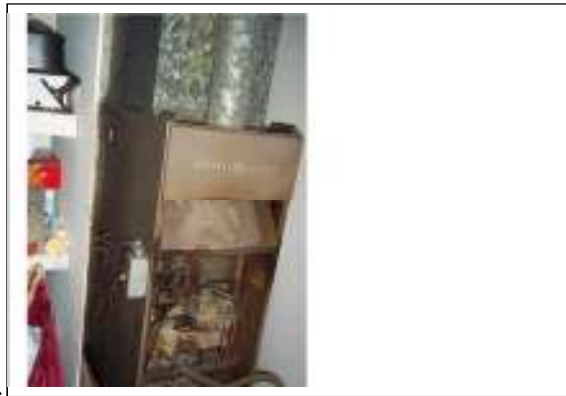
Furnace

- **Major Concern, Repair:** Given the age of the furnace, replacement should be expected now.

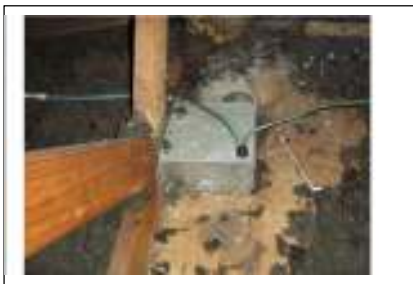
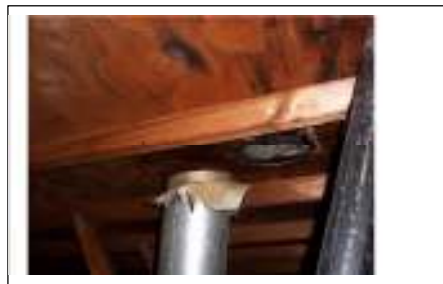
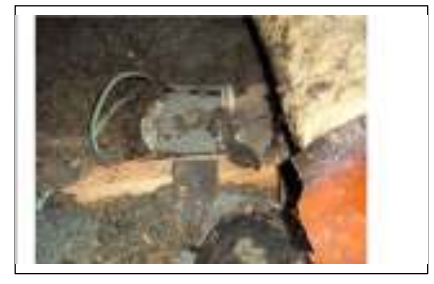
- **Improve:** The level of ventilation is marginal. It is generally recommended that one (1) square foot of free vent area be provided for every one hundred and fifty (150) square feet of ceiling area. Proper ventilation will help to keep the house cooler during warm weather and extend the life of roofing materials. In cold climates, it will help reduce the potential for ice dams on the roof and condensation within the attic.

- **Repair:** The passage of air between the soffit vents and the roof cavity appears to be obstructed. “soffit vents” should be provided and allow for free movement of air within the roof space. This area should be further investigated and improved where necessary.

- **Repair:** Exhaust vent pipes from the bathroom(s) should be vented to the building exterior. Insulation should be provided on exhaust vent pipes.

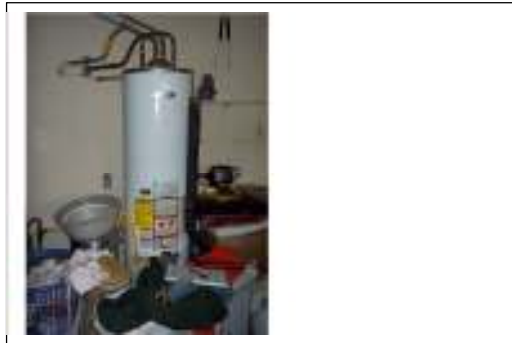
Water Heater

- **Repair:** Water heaters in seismic zones should be anchored or strapped to resist movement during earthquake conditions.
- **Improve: Safety Issue: Repair:** Given the location of the water heater, it should be better protected from physical damage. Protection from automobile contact.
- **Repair, Safety Issue:** Water heaters in garages should be on a raised platform so that the pilots, burner or heating elements are not closer than 18 inches from the garage floor.
- **Repair:** The stand under the water heater does not appear to adequately support the tank safely. Rebuilding or modifying is recommended.

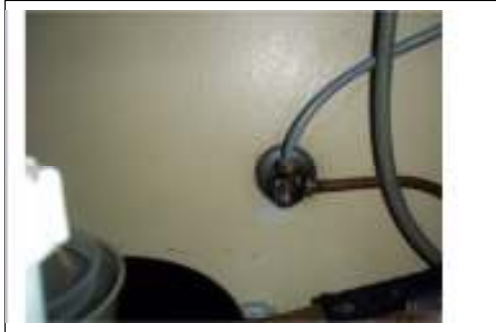
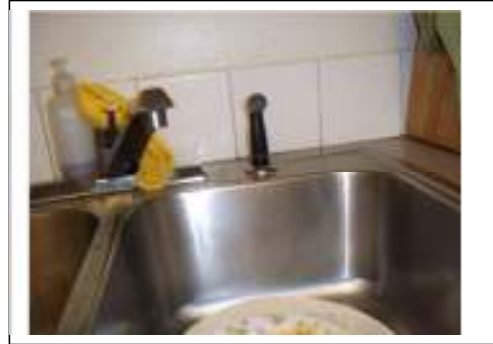
Supply Plumbing

- **Repair:** The supply piping is leaking. The meter was observed spinning at time of inspection, although no active leaks visibly observed in crawl, the crawl does have standing water, however it has sewer odor, thus the waste line should be scoped by a licensed plumber.

- **Repair:** A supply valve handle is missing below the kitchen sink and has an active leak at time of inspection. Damaged to the base of the kitchen cabinet is observed, repairs will be needed, additional investigation will be necc. Additionally the kitchen back splash has evidence of dripping below the sink caulk as needed, all water splash areas require caulk seal.

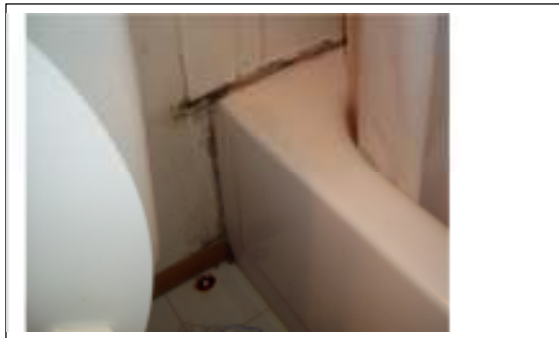
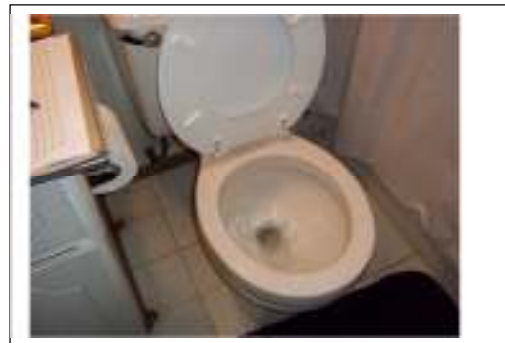
Fixtures

- **Monitor:** The majority of plumbing fixtures are old.
- **Repair: Monitor: Possible Major Concern:** The floor adjacent to the toilet shows evidence of water damage. High moisture readings surrounding the toilet extending to the tub and below the vanity, further investigation required to determine the extent of repairs, all damaged and hidden damage must be removed and replaced, the area should be thoroughly dry prior to re-covering, re-inspection is recommended prior to re-cover to determine if additional repairs or treatments are necessary prior to re-covering.
- **Repair:** Evidence of water damage to the floor adjacent to the bathtub enclosure was observed. The extent of damage is difficult to predict without removing floor coverings.

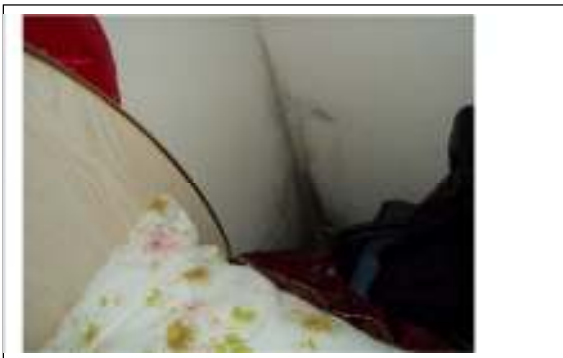
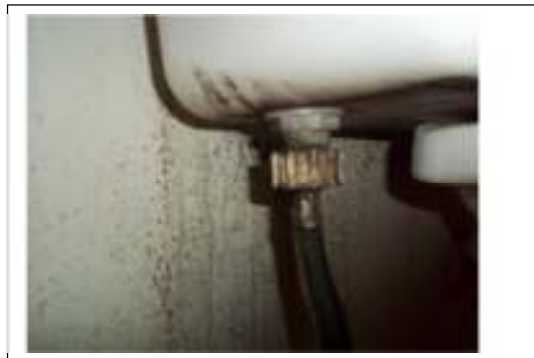
Walls / Ceilings

- **Monitor:** Water staining was noted. The area was dry at the time of the inspection, but due to the lack of recent rain we are unable to determine if the stain is still active. Recommend consulting with the current owners for additional information prior to closing. If the leak is still active, we recommend repair/replace as needed to remedy the leak.
- **Monitor:** Minor cracks were noted.
- **Monitor:** Typical drywall flaws were observed.
- **Monitor: Possible Major Concern:** Signs of mildew were observed In main bath and bedrooms, a mold screening / IAQ test is recommended on the air quality of the home.
